Case 368 : Narrative

Case Vehicle (A): 1999 Toyota	Vehicle (B): 2002 Ford
Type: Camry LE, 4-door sedan	Type: Taurus SES, 4-door sedan
Driver: 39-year-old female	Driver: 45-year-old male
CDC: 11-FLEW-2, 09-LBEW-3	CDC: 02-RFEW-3, 03-RZAW-3

CASE NO.: 368-03

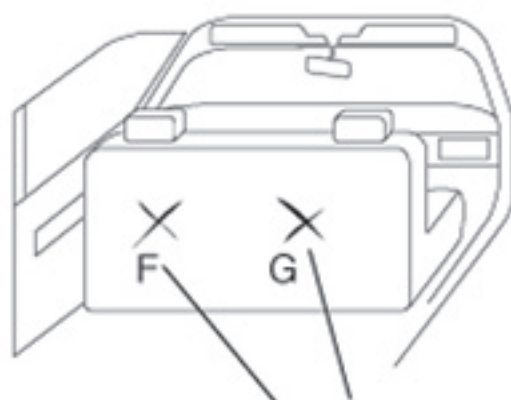
seat pushed forward and
to the left

F & G: scuff marks

E:
center floor
console broken
